D	PATE	TAIL	NUMBER	STATION	I	AIRLINE CARD NO.		BOEING		
SKILL	WO.	RK AREA	DEI	ATED TASK	VERSION	THRESHOLD	REPEA [*]	49-010-0	PHAS	
ENGIN		MPARTMENT		ATED TASK	1.1	2 YRS	2 YRS		FIAS) <u>C</u>
	5 55.						•			
	TASK				TITLE			APPLICABILITY	ENCINE	
GENE	ERAL VIS	UAL	APU MOUN	ITS			AIRPLANE		ENGINE	
	ZON	ES				ACCESS	ALL		ALL	
315 3			315	A						
									MECH	INSP
SYST	EMS									2.101
		9-010-00				MOUNTO FOR				
				Y OF INSTAL		MOUNTS FOR				
GLINE	KAL CON	DITION AND	JECORII	I OI INSTAL	LATION	•				
		erences								
	(1)	AMM TASI	K 49–13–1	1-200-801 p	601, A	PU Mounts Inspec	ction (APU R	emoved)		
	(CUSTOMER FLEET	EFFECTIVITY		SOURCE					
		A1 1			MDD	APU MOUNTS				
		ALL			MRB			PAGE	1 ^f	7
						49-010-00-00			า 10/	
										_

TASK 49-13-11-200-801

- 1. <u>APU Mounts Inspection (APU Removed)</u> (Fig. 601)
 - A. Procedure
 - (1) Do these steps to inspect the APU mounts:
 - (a) Remove the APU. To remove it, do this task: APU Power Plant Removal (AMM TASK 49-11-00-000-801 p401).
 - (b) Visually examine these parts for corrosion, cracks and damage:
 - Strut assemblies (APU mounts)
 - 2) Vibration isolators
 - 3) Cone bolts and nuts for the vibration isolator.
 - (c) If you fi

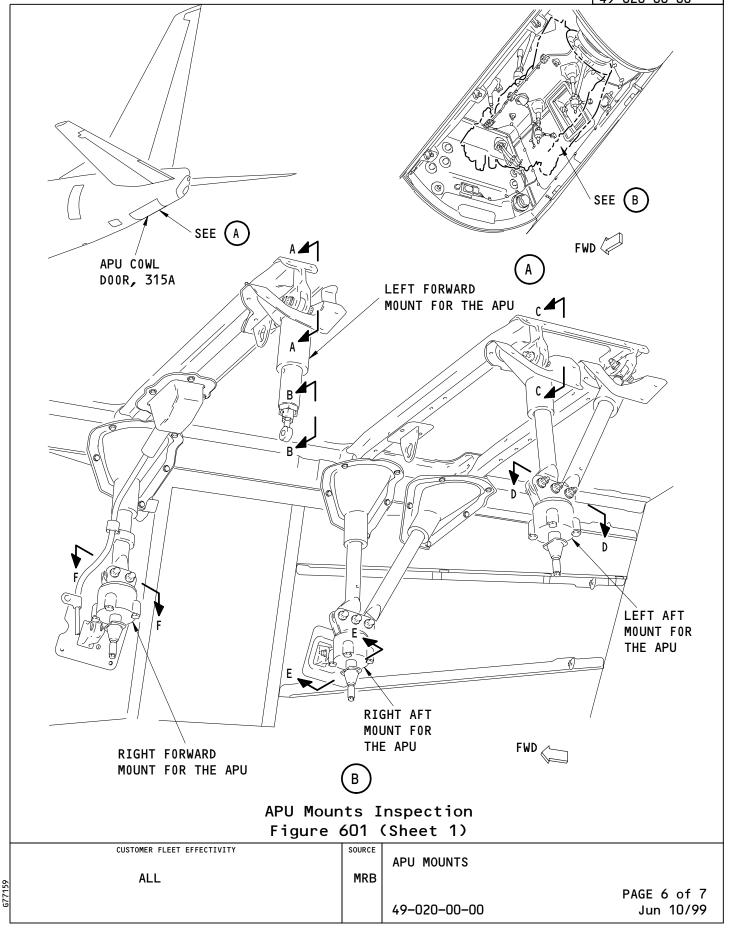
NOTE: It is necessary to remove the firewall covers to get access to the APU mounts, support brackets and mounting parts.

- 2) Visually examine the bolts and bushings for corrosion, wear and damage.
 - a) Replace the bolts and bushings that you find with corrosion or damage.
 - b) Replace all the parts that are more than the permitted wear limits shown in (Table 601).

- 3) Examine the four bolts and four lockwashers that attach each housing assembly to each vibration isolator for tightness and missing part(s).
 - a) If it is necessary, tighten the bolts or replace the missing part(s).
- 4) Visually examine the surface of each vibration isolator for scratches, nicks, burrs, corrosion, galling, fretting and wear.
 - a) If the individual damaged area is more than 0.50 inch (12.70 mm) diameter by 0.20 inch (0.51 mm) depth or 1.00 inch (25.40 mm) length by 0.10 inch (2.54 mm) width by 0.020 inch (0.51 mm) depth, replace the vibration isolator.
 - b) If the total damaged area is more than 15% of the total surface area for the vibration isolator, replace the vibration isolator.

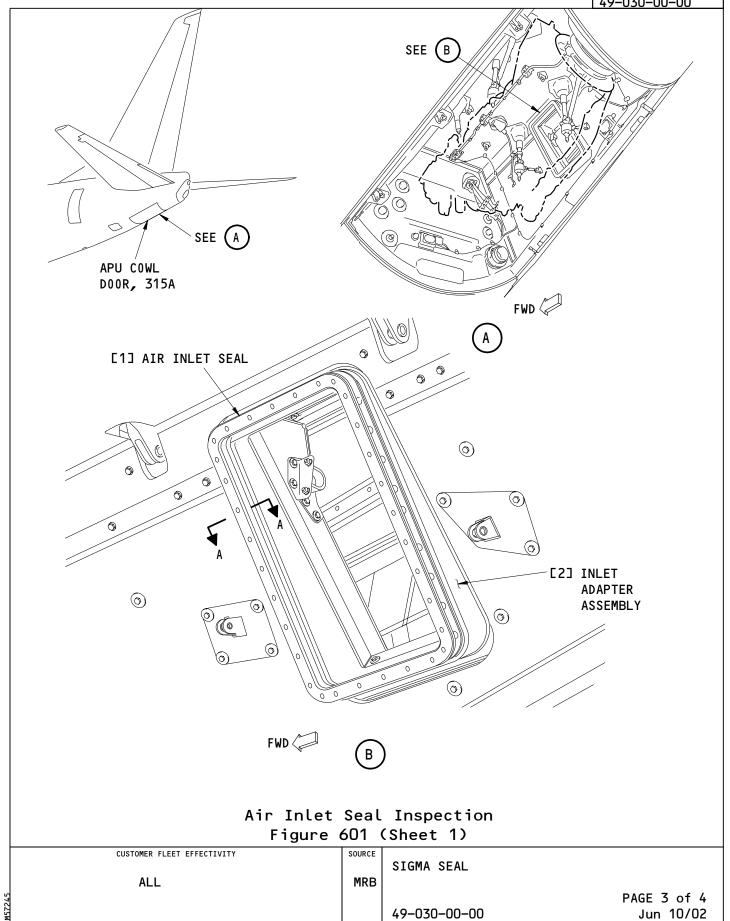
- 1. <u>Air Inlet Seal Inspection</u> (Fig. 601)
 - A. Prepare for the Removal
 - (1) Remove the APU. To remove it, do this task: APU Power Plant Removal (AMM TASK 49-11-00-000-801 p401).
 - B. Procedure
 - (1) Do these steps to inspect the air inlet seal [1]:
 - (a) Examine the air inlet seal [1] for any signs of folding, tears or deformation.
 - (b) Measure the height of the air inlet seal [1].

- (d) Examine the mating surfaces of the air inlet seal [1] for wrinkles, bubbles, unwanted materials or wear damage through the top rubber layer of fiberglass.
- (e) Examine the seven rubber layers of fiberglass for any separations, missing materials, cracks and tears.
- (f) If you find any of the above damage or the height of the air inlet seal [1] is not in the limits, replace the air inlet seal. These are the tasks:
